**Preliminary Report**  
**Accident involving Air India's B787-8 aircraft bearing registration VT-ANB**  
**at Ahmedabad on 12 June 2025**

**Government of India**  
**Ministry of Civil Aviation**  
**Aircraft Accident Investigation Bureau**

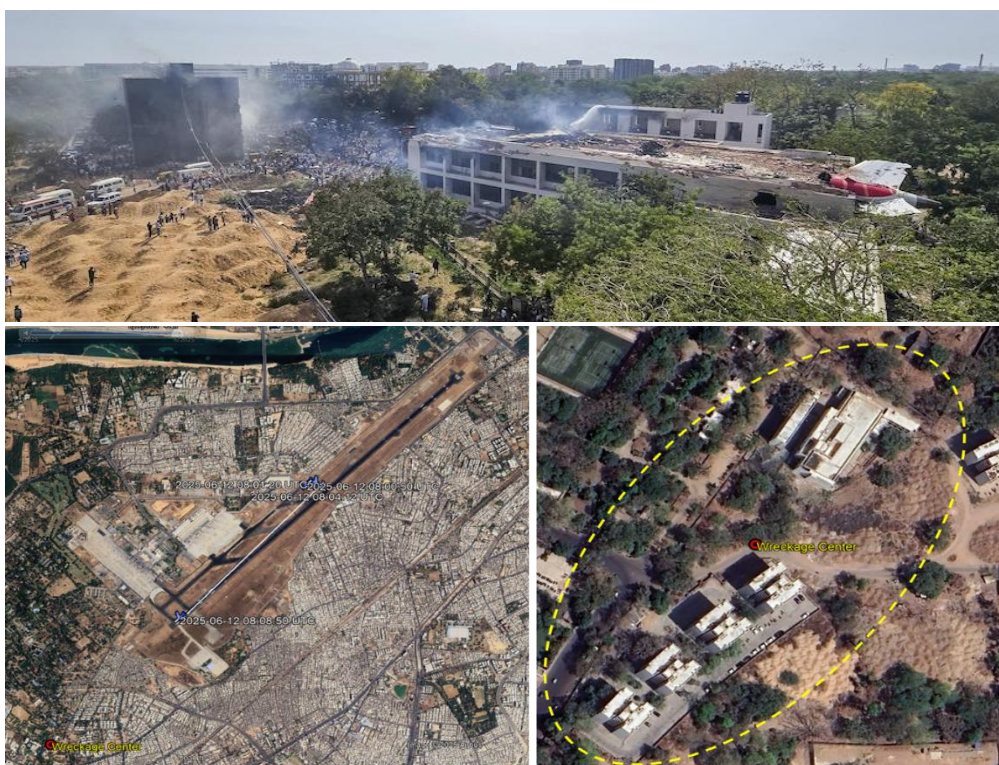
Figure 1 Accident Site with respect to airport (left) and debris field

The Aircraft was destroyed due to impact with the buildings on the ground and subsequent fire. A total of five buildings shown in the figure below were impacted and suffered major structural and fire damages.

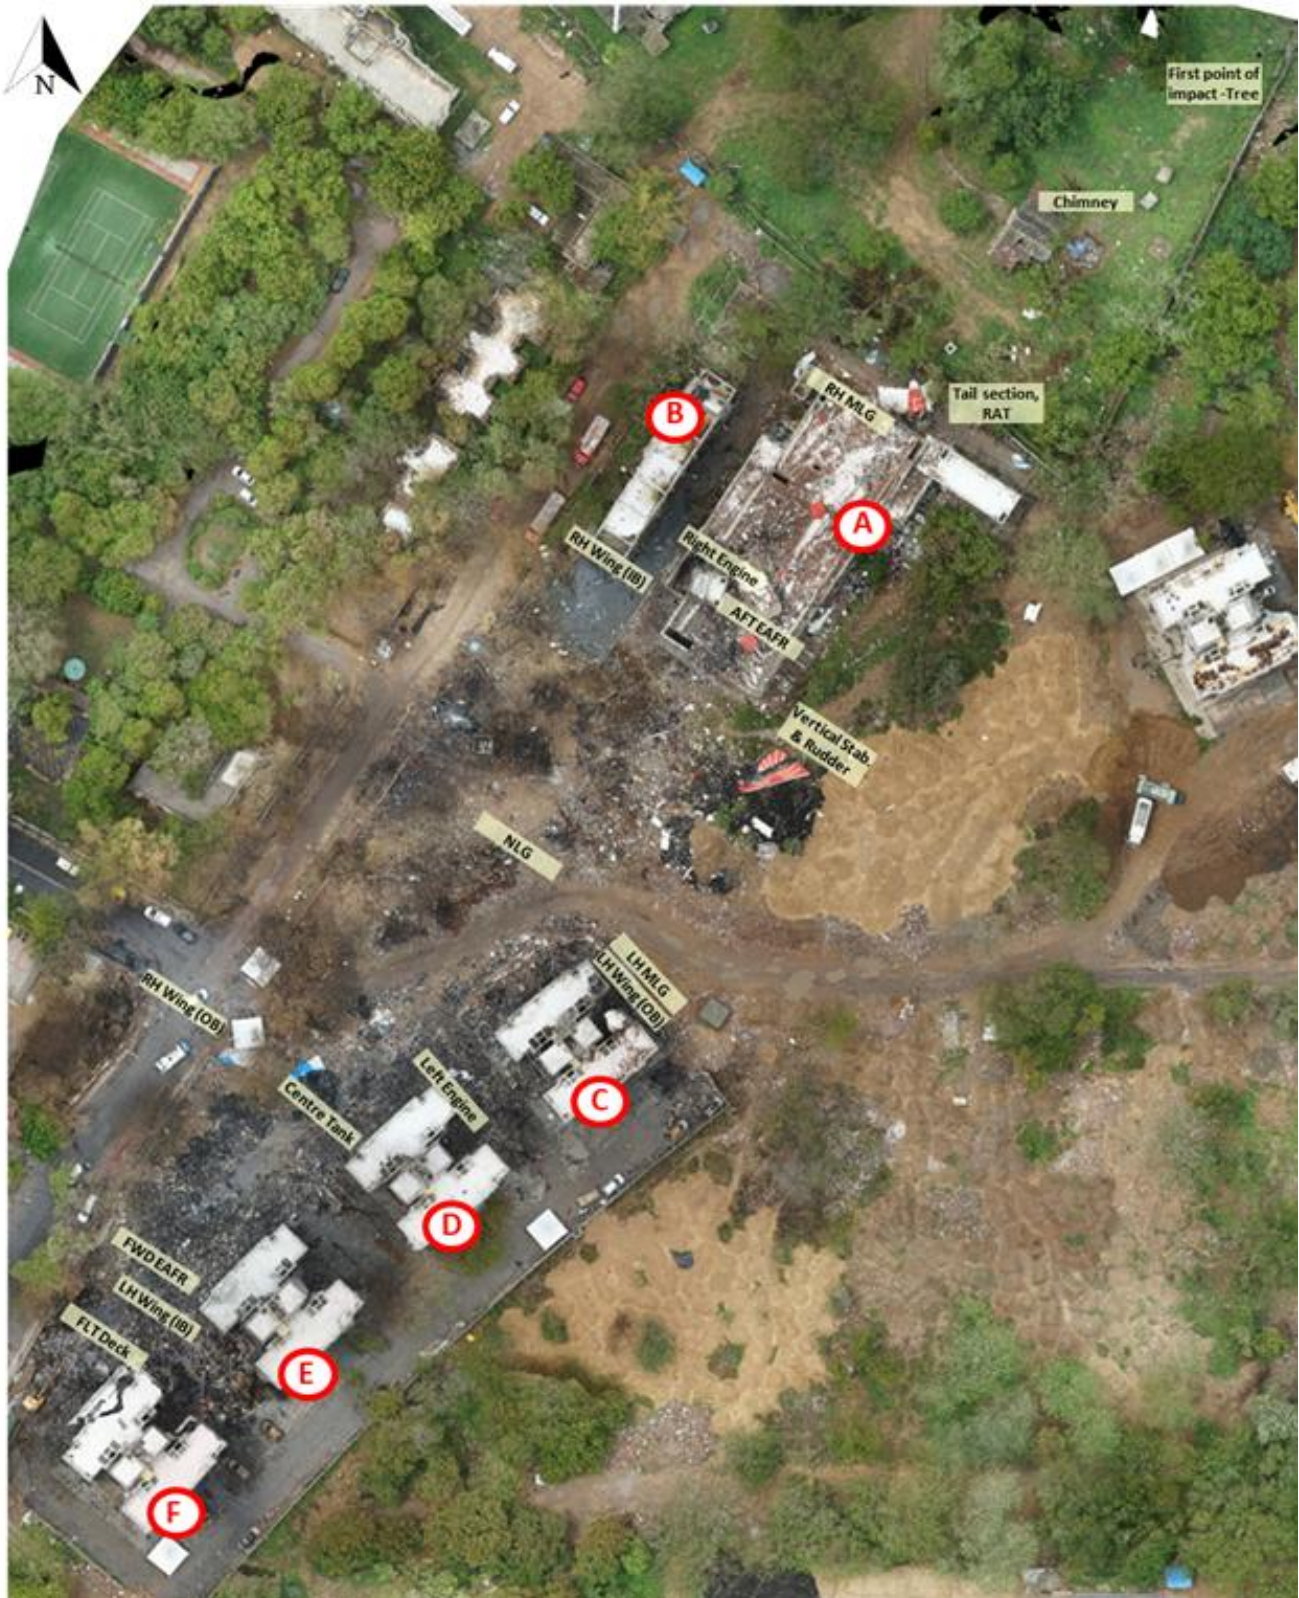
Figure 2 Wreckage layout

After takeoff, the aircraft impacted the BJ Medical College hostel which is 0.9 NM from the departure end of Runway 23. The Emergency Locator Transmitter (ELT) was not activated during this event. The wreckage, from the first impact point till the last identified aircraft item, was distributed in an area of approx. 1000 ft \* 400 ft. A layout of the crash site has been given in Fig. 2 indicating the significant parts of the aircraft. The buildings at the wreckage site have been labelled alphabetically from A-F in the layout for easy reference.

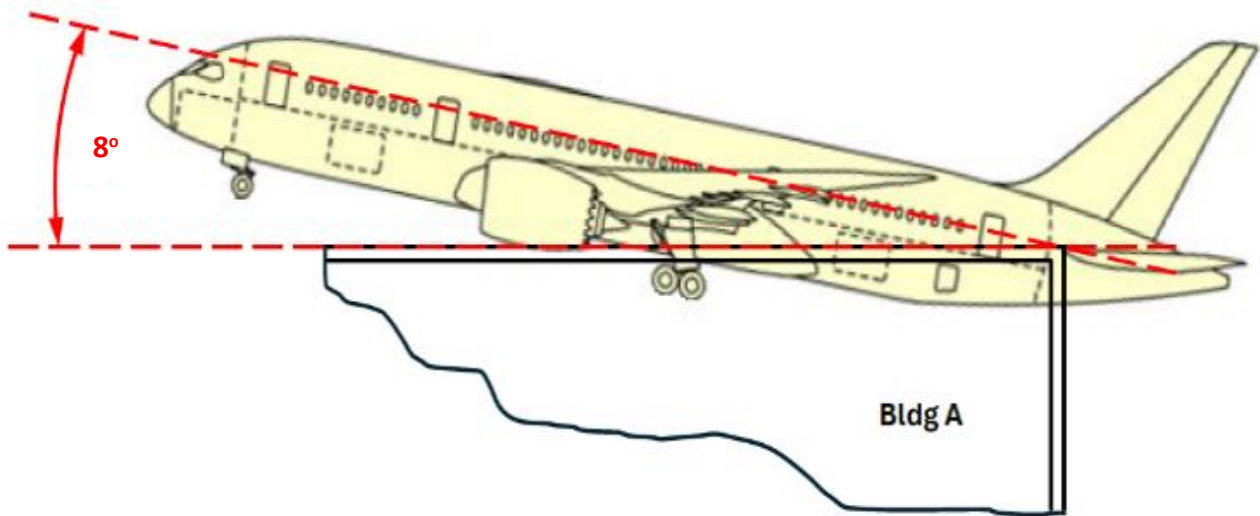
Figure 3 Aircraft attitude at the time of impact with Building A

As the aircraft was losing altitude, it initially made contact with a series of trees and an incineration chimney inside the Army Medical Corps compound before impacting the northeast wall of the Building A. The distance between the tree on which the aircraft made its initial contact and the point on the Building A where the aircraft impacted is 293 ft. As the

aircraft moved forward, it continued fragmenting and collided with other structures and vegetation. The impact witness marks on the building and airplane indicated a likely nose-up attitude (about 8°) and wings level.

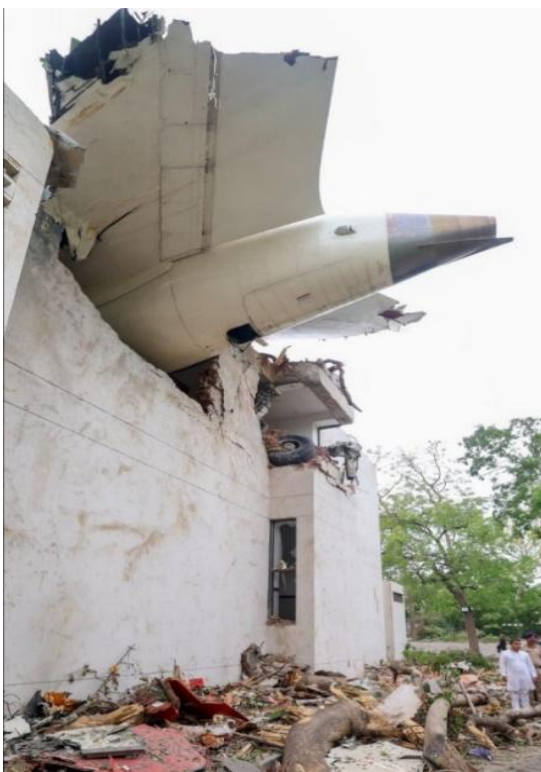
Figure 4 Tail section & RH MLG embedded in the building A

The vertical stabilizer (*fig. 5*) separated from the aft fuselage and came to rest about 200 feet south of the initial point of contact with the Building A. The tail section and the RH Main Landing Gear (MLG) of the aircraft were found embedded in the northeast wall of the Building A while the rest of the airplane continued its forward movement.

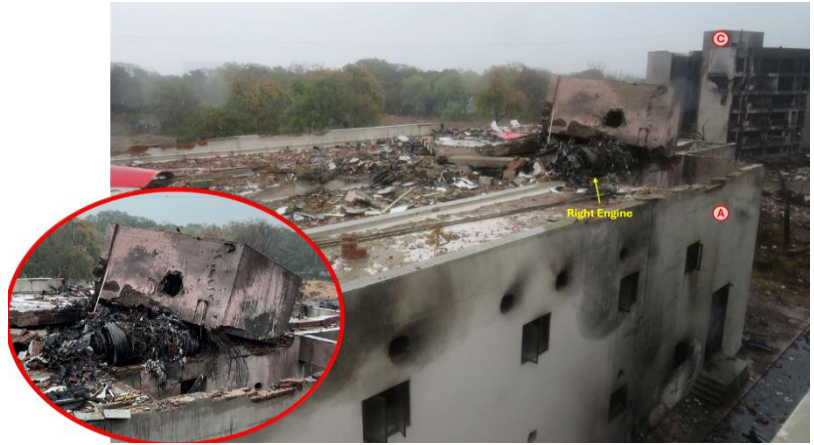
Figure 6 RH Engine

As the airplane continued its path across the roof of the Building A the right engine (fig. 6) struck the concrete water tank structure, separated from the airplane and rested underneath the water tank structure facing a heading of approx. 226 degrees near southwest wall of the Building A.

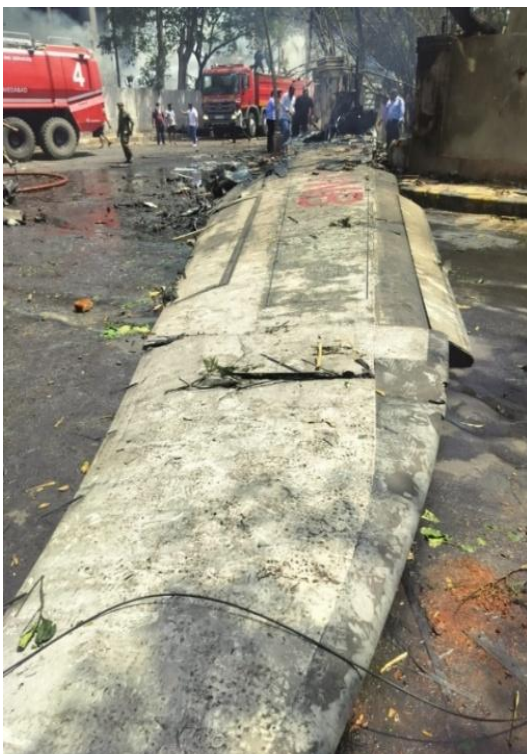
Figure 7 : RH Wing Outboard

The right-wing mid-section and the outboard section (fig.7) was about 280 feet and 520 feet southwest respectively from the initial point of contact with the Building A.

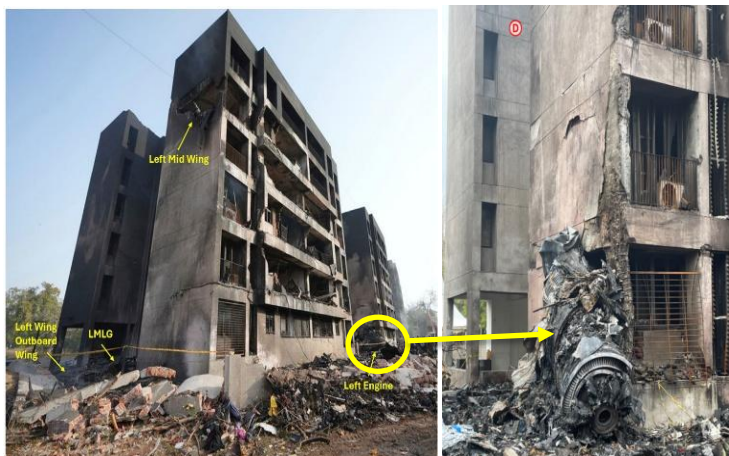
Figure 8 LH Engine

The left engine (fig.8) got separated from the airplane and struck the north corner of Building D at the ground level where it remained and was roughly perpendicular to the right engine resting position, at heading of approx. 326 degrees. The wall was pushed into the

building and the northwest building column was damaged such that portions of the concrete

were missing and exposing the internal metal rebar. The engine, remaining portions of attached cowling, and the surrounding area were heavily damaged by fire.

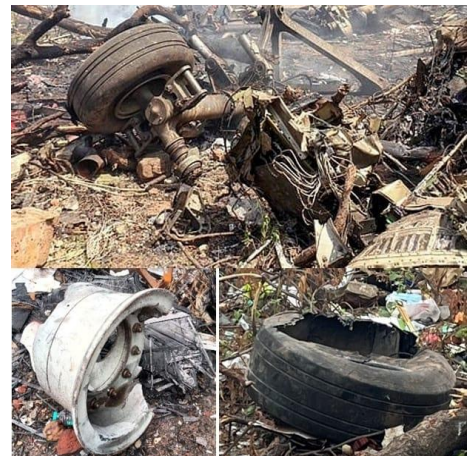
Figure 9 Nose Landing Gear

The nose landing gear (NLG) (fig. 9) was found on the ground about 307 feet southwest from the initial point of contact with Building A.

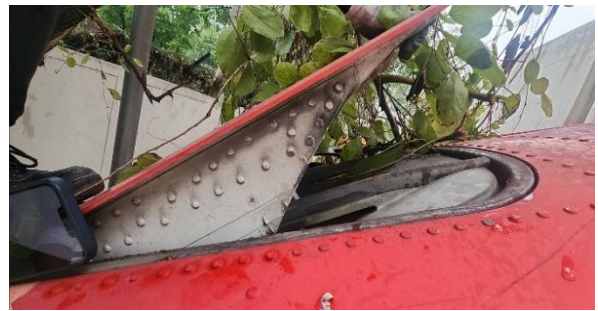
Figure 10 APU Air Inlet Door

After the tail section was brought down, the APU was inspected and found intact inside the APU compartment. The APU air inlet door (fig. 10), which was intact, was found open.

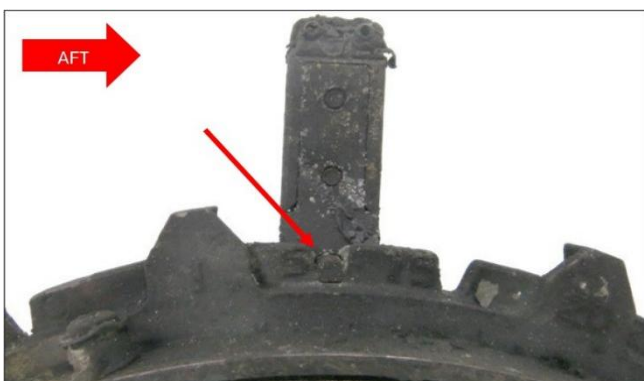
Figure 11 Flap Handle Lever

The flap handle assembly (fig.11) sustained significant thermal damage. The handle was found to be firmly seated in the 5-degree flap position, consistent with a normal takeoff flap setting. The position was also confirmed from the EAFR data. The landing gear lever was in "DOWN" position. (fig.12)

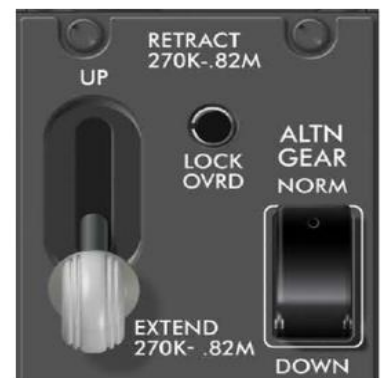
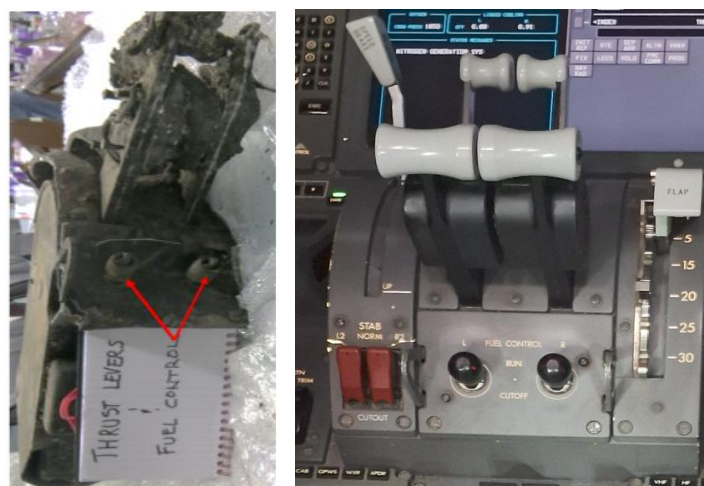
Figure 13 Thrust Lever Quadrant & Fuel Control Switch

The thrust lever quadrant sustained significant thermal damage. Both thrust levers were found near the aft (idle) position. However, the EAFR data revealed that the thrust levers remained forward (takeoff thrust) until the impact. Both fuel control switch were found in the "RUN" position. (fig.13) The reverser levers were bent but were in the "stowed" position. The wiring from the TO/GA switches and autothrottle disconnect switches were visible, but heavily damaged.

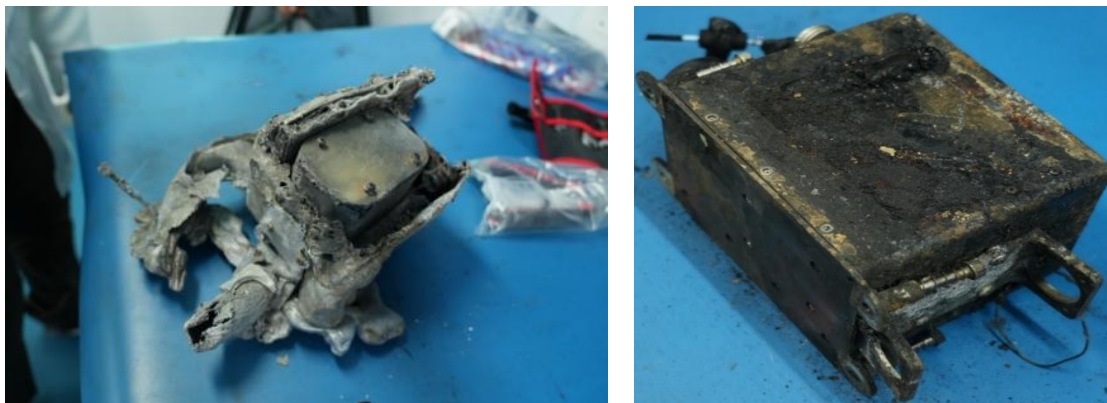
Figure 14 EAFR AFT & FWD

The aft EAFR was located on the roof top of Building A on 13<sup>th</sup> June 2025. The EAFR had impact and thermal damages to the housing. The wires were protruding from the housing and the connectors were burnt.

The forward EAFR was located on 16<sup>th</sup> June 2025 from the wreckage debris besides the Building F. The EAFR was burnt and covered in soot. The EAFR was still attached to the

equipment shelf with part of the connector melted but still connected. The ULB was still connected to the housing and the lithium battery was also attached to the equipment shelf, which was removed later prior to transportation.

**The aft EAFR was substantially damaged and could not be downloaded through conventional means. The CPM was opened to inspect the memory card. The damage was extensive.**

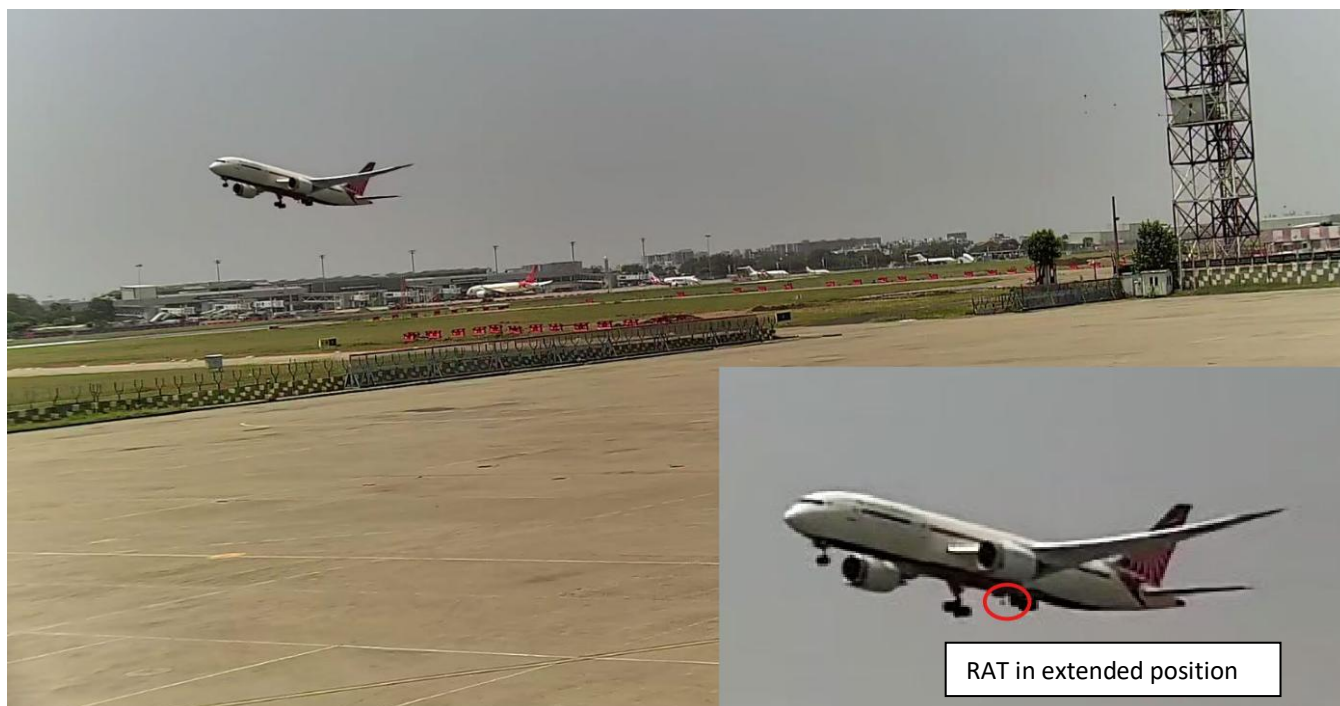
Figure 15 CCTV screenshot of RAT Deployment

The CCTV footage obtained from the airport showed Ram Air Turbine (RAT) getting deployed during the initial climb immediately after lift-off (*fig. 15*). No significant bird activity is observed in the vicinity of the flight path. The aircraft started to lose altitude before crossing the airport perimeter wall.
